**Flood Control Project Maintenance  
Levee Inspections**

**Fall 2015 Levee Maintenance Deficiency Summary Report**

**San Joaquin River Basin**

**Reclamation District No. 2089 Stark**

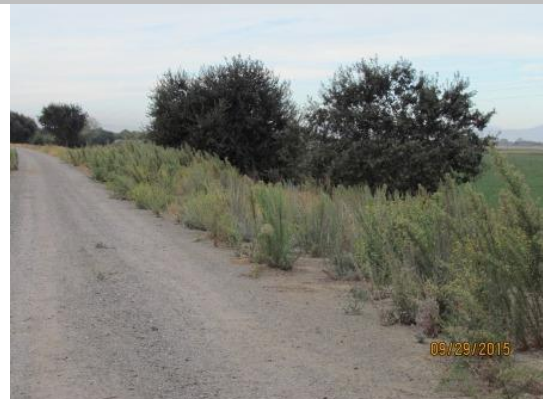
Photo 1 of 1 : FA\_2015\_RD2089\_316\_42\_20151005\_00036.jpg

View of the tall vegetation obstructing visibility of the landside levee slope.

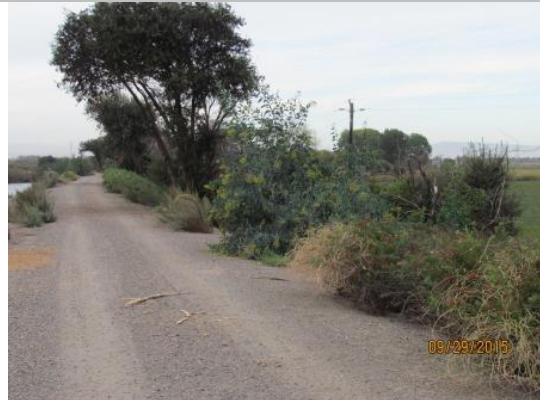
Photo 1 of 1 : FA\_2015\_RD2089\_316\_12\_20151005\_00038.jpg

Thick brush and wild rose completely block access and visibility of landside slope and toe.

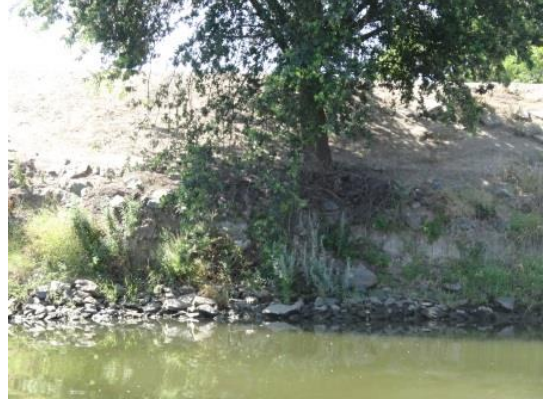
Photo 1 of 1 : SJR2015\_RD2089U01RM29.94\_1.jpg

Front view of the erosion site. Note the large tree above the erosion.

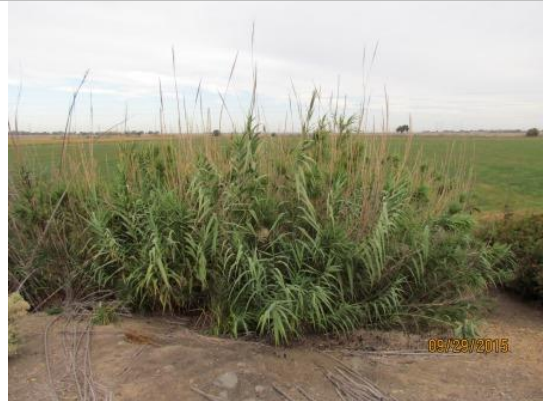
Photo 1 of 1 : FA\_2015\_RD2089\_316\_19\_20151005\_00039.jpg

LM Start	0.33	Rating **	U	Issue No.	19
LM End	0.33	Issue Type +	Ma	Location *	LS
Category	Earthen Levee			GPS Latitude/Longitude	
				Start	End
Item	Vegetation			37.809983 °	37.809983
				-121.390678 °	-121.390678
DWR ID	DWR_RD2089_01_s_2012_19				
Action/Comments					
Remove the wild growth other than native grasses from the levee slopes. Inspector Comments: Bamboo completely blocks access and visibility.11/10/2011 Arundo has been trimmed back from the roadway, but still completely blocks access and visibilit to the landside slope. This plant was improperly identified as bamboo in previous inspections.

Arundo has been trimmed back from the road, but needs to be removed so that it does not obstruct visibility and access to the landside toe.

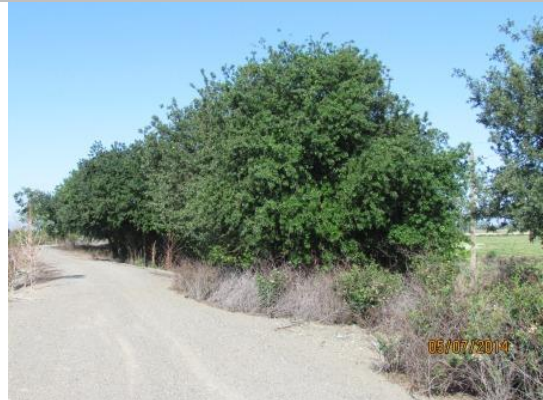
Photo 1 of 1 : FA\_2015\_RD2089\_316\_946\_20150910\_00031.jpg

Trees on levee slope obstruct access and visibility.

LM Start	0.37	Rating **	U	Issue No.	946
LM End	0.37	Issue Type +	Ma	Location *	LS
Category	Earthen Levee			GPS Latitude/Longitude	
				Start	End
Item	Trim / Thin Trees			37.809865 °	37.809865 °
				-121.391303 °	-121.391303 °
DWR ID	DWR_RD2089_01_s_2012_946				
Action/Comments					
Trim trees to at least five feet above ground level.

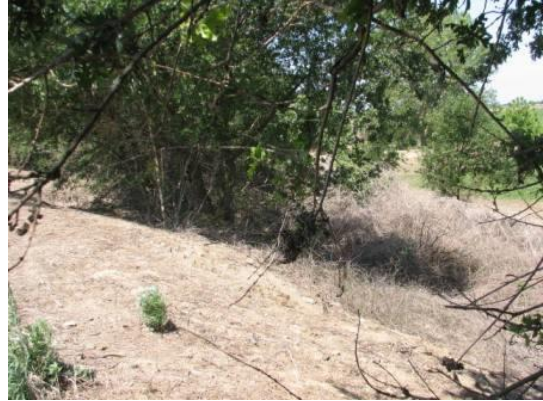
Photo 1 of 1 : FA\_2015\_RD2089\_316\_28\_20150910\_00016.jpg

05/24/2011 Photo shows thick dead vegetation and continuation of trees in area that are preventing access and visibility of landside slope and toe.

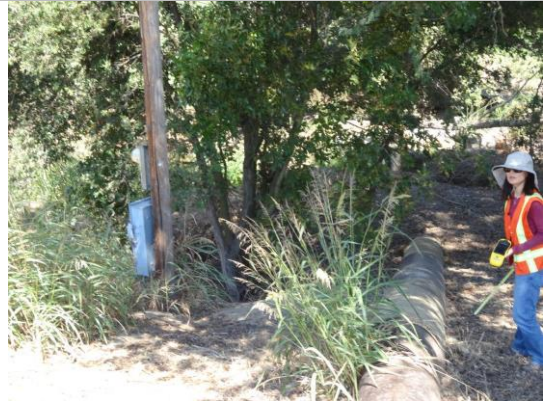
Photo 1 of 3 : UCIP\_FA\_2015\_2272.jpg

LM Start	0.46	Rating **	M	Issue No.	958
LM End	0.46	Issue Type +	En	Location *	LS
Category	Supplemental			GPS Latitude/Longitude	
				Start	End
Item	DWR UCIP Field Study			37.809501 °	37.809501 °
				-121.392798 °	-121.392798 °
DWR ID					
Action/Comments					
Inspector Comments: FS_ID:21635					
DS_ID:23042					
EP_NO: 5641					
FS_HLM: 0.4614					
Repair Type: Non-Urgent					
Crossing Status: Found					
UCIP Comments: - damaged siphon breaker.- most of the pipe on					
landside exposed on levee slope.					
FIELD_STRUCT_DESC: 20-inch steel pipe and electric conduit through					
the levee, 5.8 feet below the crown, pump on pile structure in the					
stream. Siphon breaker on the landward slope. (App. No. 5641- Ted					
Stark)					
FS Date: 09/12/2013

LS view: overview of exposed steel pipe (right) on levee slope and service pole (left).

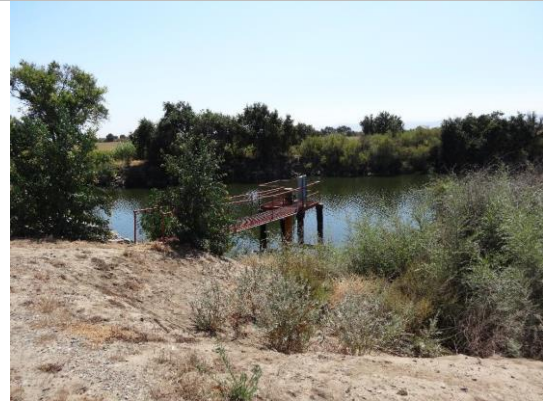
Photo 3 of 3 : UCIP\_FA\_2015\_2282.jpg

Inspector Comments: FS\_ID:21635  
 DS\_ID:23042  
 EP\_NO: 5641  
 FS\_HLM: 0.4614  
 Repair Type: Non-Urgent  
 Crossing Status: Found  
 UCIP Comments: - damaged siphon breaker.- most of the pipe on landside exposed on levee slope.  
 FIELD\_STRUCT\_DESC: 20-inch steel pipe and electric conduit through the levee, 5.8 feet below the crown, pump on pile structure in the stream. Siphon breaker on the landward slope. (App. No. 5641- Ted Stark)  
 FS Date: 09/12/2013

WS view: walkway to pump platform and pump on steel piling structure in the channel.

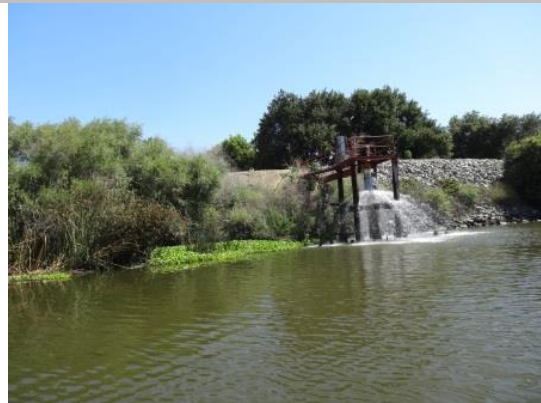
Photo 2 of 2 : SJR2015\_RD2089U01RM29.8\_9.jpg

LM Start	0.46	Rating **	M	Issue No.	5
LM End	0.46	Issue Type +	Ma	Location *	WS
Category	Supplemental			GPS Latitude/Longitude	
				Start	End
Item	DWR Erosion Survey			37.809394 °	37.809394 °
				-121.392791 °	-121.392791 °
DWR ID					
Action/Comments					
Inspector Comments: 06/25/2015: No significant change observed. 07/02/2014: No significant change observed. 08/13/2013: No significant change observed. 08/07/2012: The site has been visited by boat survey. No significant change observed 08/23/2011: The site shows loose material around the pipe crossing.

Front view of the site.

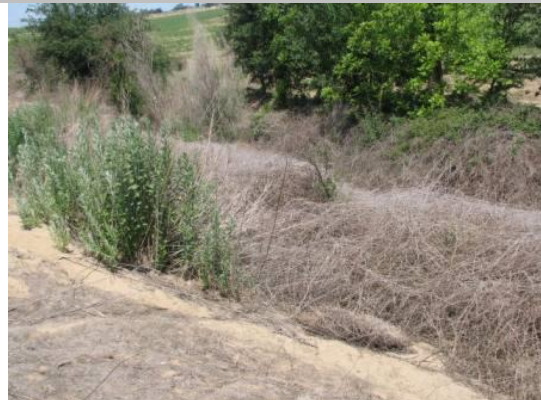
Photo 1 of 1 : FA\_2015\_RD2089\_316\_30\_20150910\_00017.jpg

LM Start	0.48	Rating **	U	Issue No.	30
LM End	0.48	Issue Type +	Ma	Location *	LS
Category	Earthen Levee			GPS Latitude/Longitude	
				Start	End
Item	Vegetation			37.809665 °	37.809665 °
				-121.393219 °	-121.393219 °
DWR ID	DWR_RD2089_01_s_2012_30				
Action/Comments					
Remove the wild growth other than native grasses from the levee slopes. Inspector Comments: Dead growth is too thick to allow access during flood fight situation and completely obstructs visibility of the landside toe.

05/24/2011 Dead brush is too thick to allow access and visibility of landside slope and toe.

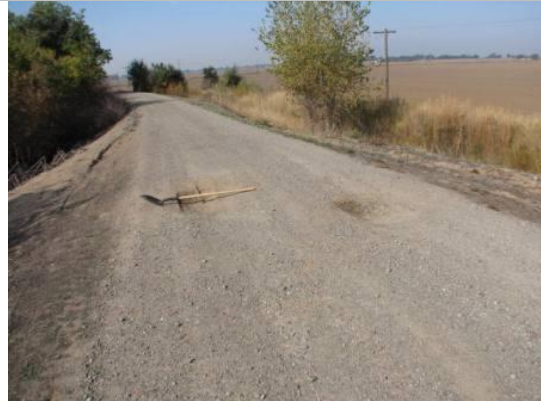
Photo 1 of 1 : FA\_2015\_RD2089\_316\_14\_20150910\_00008.jpg

LM Start	0.54	Rating **	M	Issue No.	14
LM End	0.54	Issue Type +	Ma	Location *	CR
Category	Earthen Levee			GPS Latitude/Longitude	
				Start	End
Item	Crown Surface / Depressions / Rutting			37.810087 °	37.810087 °
				-121.394200 °	-121.394200 °
DWR ID	DWR_RD2089_01_s_2012_14				
Action/Comments					
Add appropriate gravel or road base. Grade and compact. Inspector Comments: 11/10/2011 Minor depressions will cause ponding.

11/10/2011 Depressions in crown.

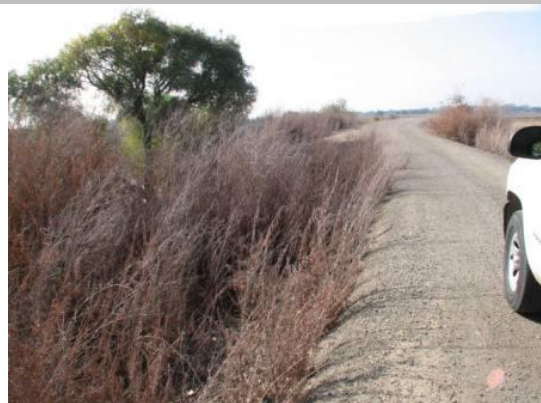
Photo 1 of 1 : FA\_2015\_RD2089\_316\_18\_20150910\_00011.jpg

11/10/2011 Vegetation needs to be cleared on the upper 20' of the waterside slope.

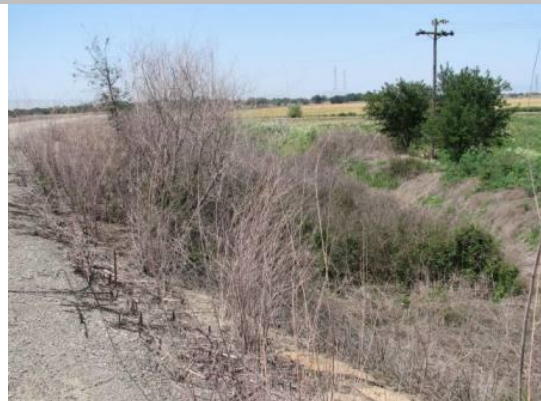
Photo 1 of 1 : FA\_2015\_RD2089\_316\_31\_20150910\_00018.jpg

05/24/2011 Vegetation is mostly dead but needs to be removed to allow access and visibility of slope and toe.

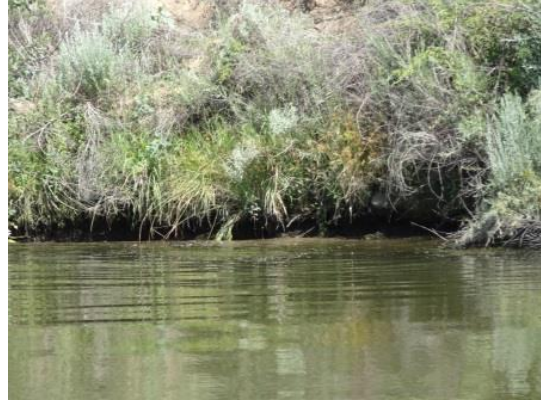
Photo 1 of 3 : SJR2015\_RD2089U01RM29.61\_3.jpg

Inspector Comments: 06/25/2015: No significant change observed.  
 07/02/2014: No significant change observed.  
 08/13/2013: No significant change observed.  
 08/07/2012: The site has been visited by boat survey. No significant change observed  
 08/23/2011: The 5-foot vertical scarp shows no significant change from the last year inspection. No new erosion activities observed. Dense white willow trees on site.  
 09/07/2010: It was difficult to view the erosion due to the thick Willow thickets and other vegetation at the water line. At the time of the inspection, there were no signs of repair on site. As noted during the last survey, there is a 5-foot vertical scarp along the lower slope that may be subjected to high flow velocities.  
 08/05/2010: Recommended for repair, per CLRO; "Erosion of this site may be subjective to rapid rates of erosion."  
 09/28/2009: No major change observed; 5-foot vertical scarp is immediately downstream of where berm has tapered; site is recommended as local maintenance issue, per CLRO CES Evaluation 2008 Report; Site # is the same as RM29.6, LM0.60; previously rated "U".

11/05/2008: No change observed; rodent holes on lower slope; wide levee crown. [2015 Site ID:RD2089U01RM29.61]

Front view of the site. Note the erosion is invisible because of the dense vegetation.

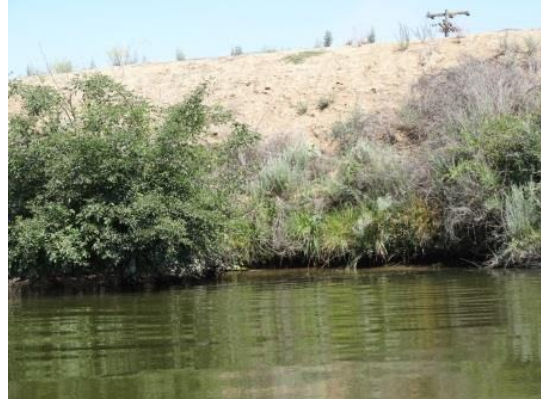
Photo 2 of 3 : SJR2015\_RD2089U01RM29.61\_4.jpg

Front view of the site. The scarp is visible on the slope.

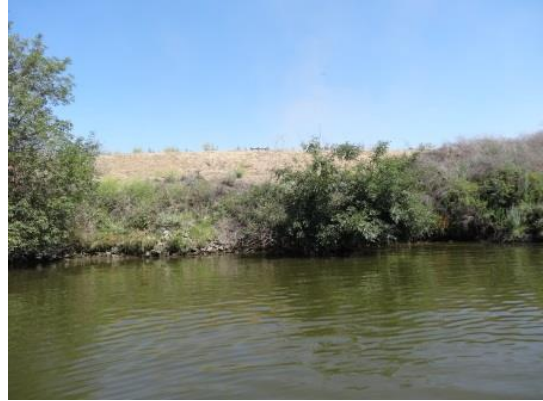
Photo 3 of 3 : SJR2015\_RD2089U01RM29.61\_9.jpg

LM Start	0.67	Rating **	U	Issue No.	3 (cont)	
LM End	0.67	Issue Type +	Ma	Location *	WS	
Category	Supplemental			GPS Latitude/Longitude		
				Start	End	
Item	DWR Erosion Survey			37.809780 °	37.809780 °	
				-121.396230 °	-121.396230 °	
DWR ID						
Action/Comments						
Inspector Comments: 06/25/2015: No significant change observed. 07/02/2014: No significant change observed. 08/13/2013: No significant change observed. 08/07/2012: The site has been visited by boat survey. No significant change observed 08/23/2011: The 5-foot vertical scarp shows no significant change from the last year inspection. No new erosion activities observed. Dense white willow trees on site. 09/07/2010: It was difficult to view the erosion due to the thick Willow thickets and other vegetation at the water line. At the time of the inspection, there were no signs of repair on site. As noted during the last survey, there is a 5-foot vertical scarp along the lower slope that may be subjected to high flow velocities. 08/05/2010: Recommended for repair, per CLRO; "Erosion of this site may be subjective to rapid rates of erosion." 09/28/2009: No major change observed; 5-foot vertical scarp is immediately downstream of where berm has tapered; site is recommended as local maintenance issue, per CLRO CES Evaluation 2008 Report; Site # is the same as RM29.6, LM0.60; previously rated "U". 11/05/2008: No change observed; rodent holes on lower slope; wide levee crown. [2015 Site ID:RD2089U01RM29.61]

Front view of the site.

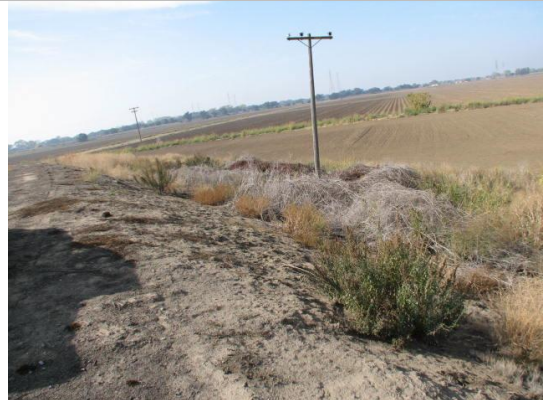
Photo 1 of 1 : FA\_2015\_RD2089\_316\_20\_20150910\_00013.jpg

11/10/2011 Vegetation obstructs visibility of slope and toe.

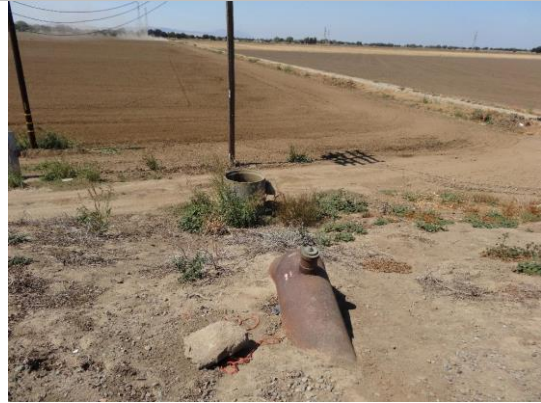
Photo 1 of 3 : UCIP\_FA\_2015\_2413.jpg

LM Start	0.80	Rating **	M	Issue No.	959
LM End	0.80	Issue Type +	En	Location *	LS
Category	Supplemental			GPS Latitude/Longitude	
				Start	End
Item	DWR UCIP Field Study			37.808387 °	37.808387 °
				-121.397843 °	-121.397843 °
DWR ID					
Action/Comments					
Inspector Comments: FS_ID:21587 DS_ID:23043 EP_NO: 3385 FS_HLM: 0.8125 Repair Type: Non-Urgent Crossing Status: Found UCIP Comments: - powerline on landside.- electric control box on waterside.- waterside slope erosion under pump platform. FIELD_STRUCT_DESC: 16-inch pipe through the levee, 5.5 feet below the crown, slant pump in pump house on the waterward slope. Siphon breaker on the landward slope. (App. No. 3385-Elinore Lawrence). Originally included in O+M (1968) FS Date: 09/12/2013

LS view: exposed pipe with siphon breaker on levee slope. Concrete standpipe on levee toe.

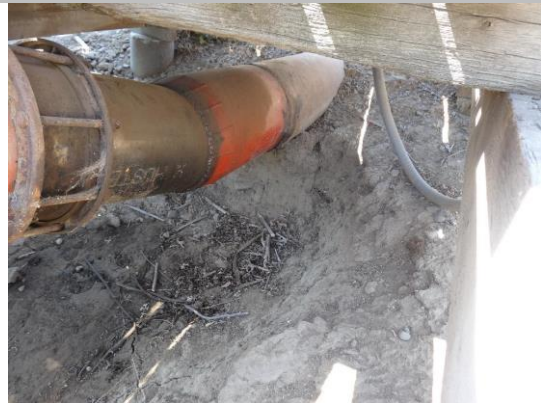
Photo 2 of 3 : UCIP\_FA\_2015\_2414.jpg

WS view: soil erosion under pump platform. Needs mitigation measures to stop erosion.

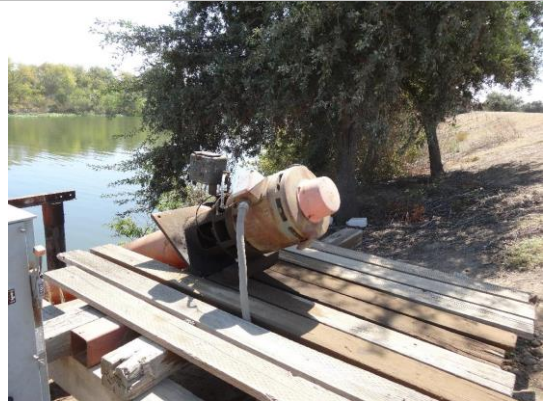
Photo 3 of 3 : UCIP\_FA\_2015\_2415.jpg

LM Start	0.80	Rating **	M	Issue No.	959 (cont)
LM End	0.80	Issue Type +	En	Location *	LS
Category	Supplemental			GPS Latitude/Longitude	
				Start	End
Item	DWR UCIP Field Study			37.808387 °	37.808387 °
				-121.397843 °	-121.397843 °
DWR ID					
Action/Comments					
Inspector Comments: FS_ID:21587					
DS_ID:23043					
EP_NO: 3385					
FS_HLM: 0.8125					
Repair Type: Non-Urgent					
Crossing Status: Found

WS view: slant pump on wooden platform. Oil leaks from the pump.

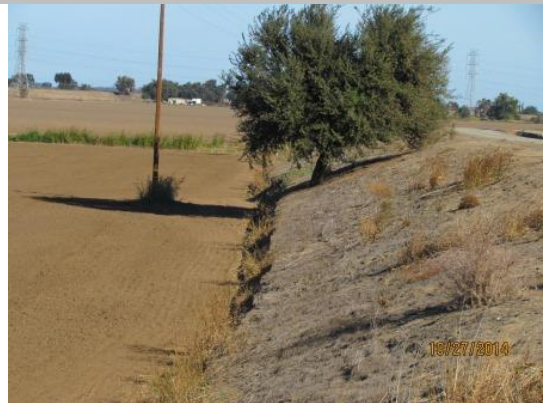
Photo 1 of 1 : FA\_2015\_RD2089\_316\_17\_20150910\_00010.jpg

LM Start	0.81	Rating **	M	Issue No.	17
LM End	0.94	Issue Type +	Ma	Location *	LS
Category	Earthen Levee			GPS Latitude/Longitude	
				Start	End
Item	Slope Stability			37.808319 °	37.806453 °
				-121.397881 °	-121.397755 °
DWR ID	DWR_RD2089_01_f_2014_17				
Action/Comments					
Repair slope instability.					
Inspector Comments: Landside levee toe cut due to farming.

View of the vertical cut along the landside levee toe.

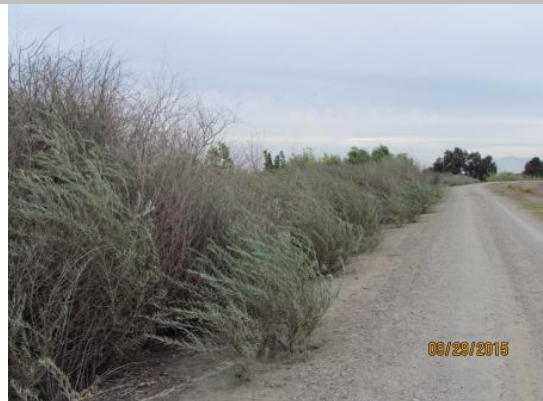
Photo 1 of 1 : FA\_2015\_RD2089\_316\_36\_20151005\_00040.jpg

View of tall willows obstructing visibility on waterside slope.

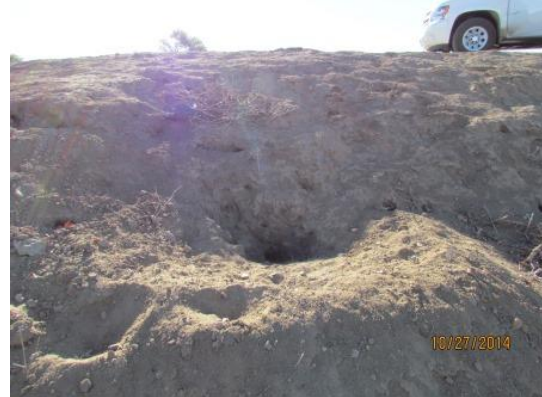
Photo 1 of 1 : FA\_2015\_RD2089\_316\_16\_20150910\_00009.jpg

View of the rodent burrow on the landside levee slope.

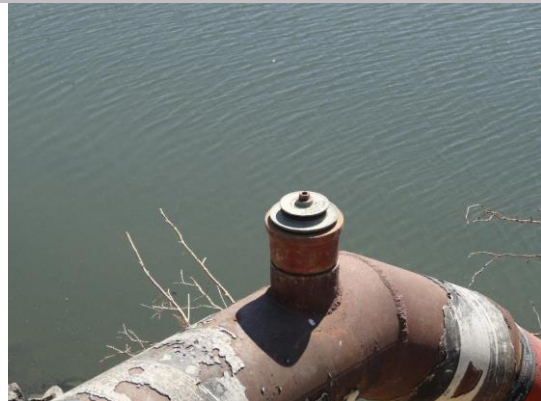
Photo 2 of 3 : UCIP\_FA\_2015\_2508.jpg

Inspector Comments: FS\_ID:21754  
 DS\_ID:23044  
 EP\_NO: 3585  
 FS\_HLM: 1.544  
 Repair Type: Urgent  
 Crossing Status: Found  
 UCIP Comments: - huge slope erosion on landside slope.- most of the pipe exposed on levee slope.- service pole on landside.  
 FIELD\_STRUCT\_DESC: 12-inch pipe through levee, 3.0 feet below the crown. Pump over concrete pipe in drain ditch on the landside. Siphon breaker on the waterside slope and air vent on landside. (App. No. 3585 - Elinore Lawrence). Originally included in O+M (1968)  
 FS Date: 09/12/2013

WS view: siphon breaker on pipe hinge on levee slope.

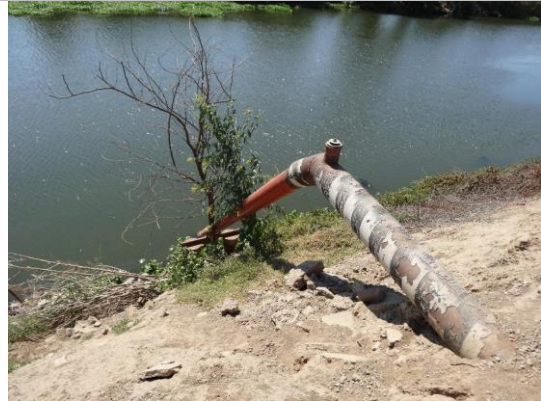
Photo 3 of 3 : UCIP\_FA\_2015\_2509.jpg

LM Start	1.14	Rating **	U	Issue No.	960 (cont)
LM End	1.14	Issue Type +	En	Location *	LS
Category	Supplemental			GPS Latitude/Longitude	
				Start	End
Item	DWR UCIP Field Study			37.805644 °	37.805644 °
				-121.401177 °	-121.401177 °
DWR ID					
Action/Comments					
Inspector Comments: FS_ID:21754					
DS_ID:23044					
EP_NO: 3585					
FS_HLM: 1.544					
Repair Type: Urgent					
Crossing Status: Found

WS view: most of the waterside pipe exposed on levee slope.

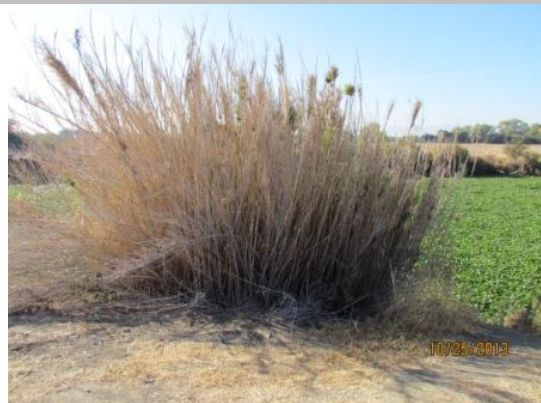
Photo 1 of 1 : FA\_2015\_RD2089\_316\_25\_20150910\_00015.jpg

View of the Arrundo on the waterside slope obstructing visibility. LMA is actively trying to remove the wild growth.

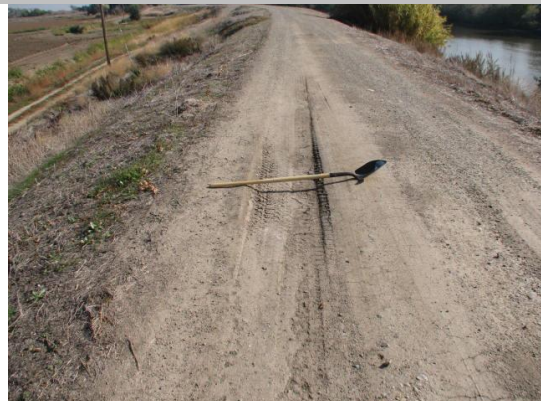
Photo 1 of 1 : FA\_2015\_RD2089\_316\_43\_20150910\_00023.jpg

11/10/2011 Depression in roadway.

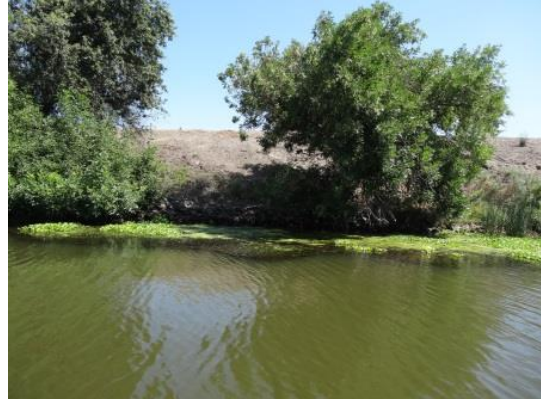
Photo 1 of 2 : SJR2015\_RD2089U01RM29.04\_1.JPG

LM Start	1.23	Rating **	M	Issue No.	2
LM End	1.24	Issue Type +	Ma	Location *	WS
Category	Supplemental			GPS Latitude/Longitude	
				Start	End
Item	DWR Erosion Survey			37.805580 °	37.805580 °
				-121.403010 °	-121.403010 °
DWR ID					
Action/Comments					
Inspector Comments: 06/25/2015: No significant change observed. 07/02/2014: No significant change observed. 08/13/2013: The erosion is around a tree at the levee toe. Dense vegetation is visible. [2015 Site ID:RD2089U01RM29.04]

View of the erosion from the survey boat.

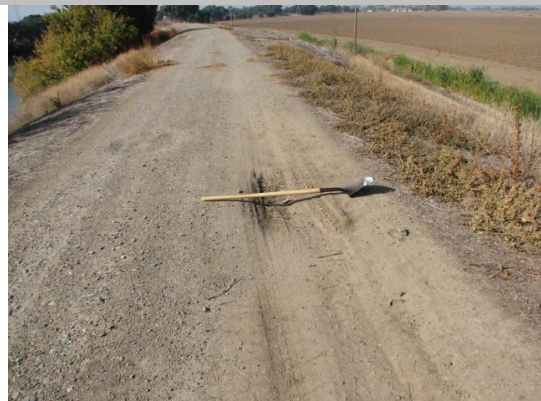
Photo 1 of 1 : FA\_2015\_RD2089\_316\_44\_20150910\_00024.jpg

11/10/2011 Roadway depression.

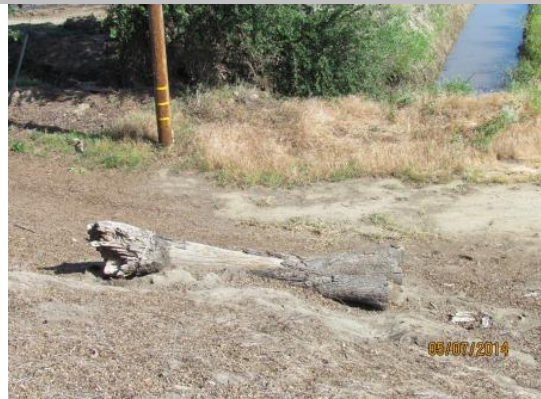
Photo 1 of 1 : FA\_2015\_RD2089\_316\_46\_20150910\_00026.jpg

Decaying tree at the landside levee toe is obstructing visibility and access.

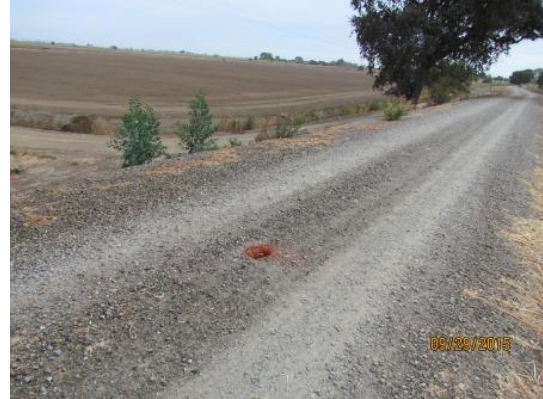
Photo 1 of 1 : FA\_2015\_RD2089\_316\_26\_20151005\_00041.jpg

View of the rodent hole on the levee crown.

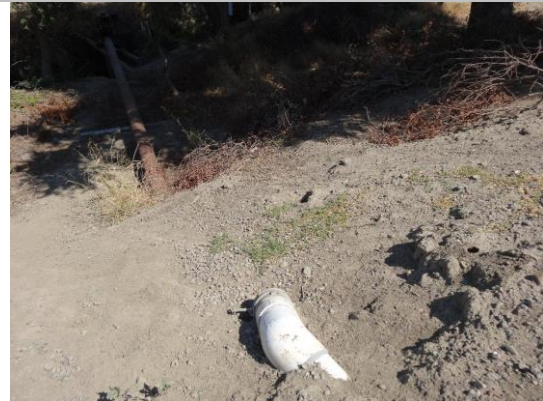
Photo 1 of 3 : UCIP\_FA\_2015\_1799.jpg

LS view: 6-inch pvc pipe on levee slope. Pipe end open.

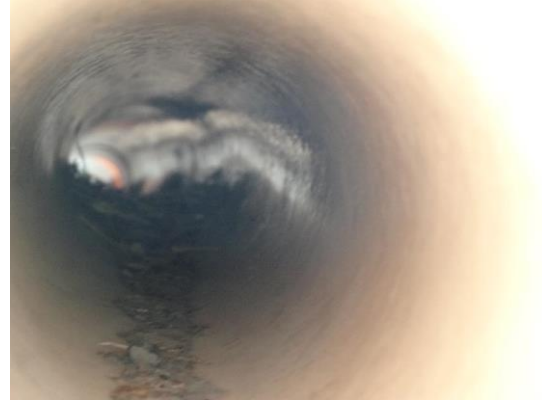
Photo 2 of 3 : UCIP\_FA\_2015\_1800.jpg

WS view: inside view of pvc pipe. Sediments found inside the pipe.

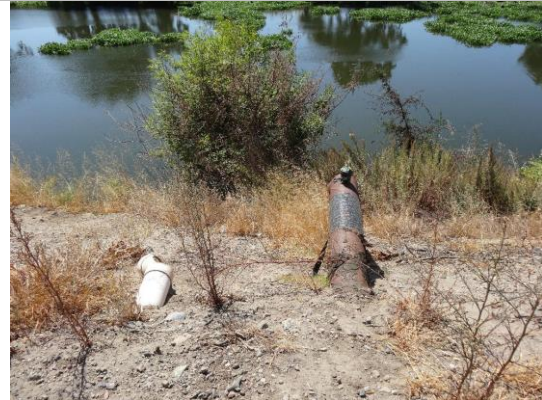
Photo 3 of 3 : UCIP\_FA\_2015\_1801.jpg

WS view: 6-inch pvc pipe on levee slope. Pipe end open and damaged.

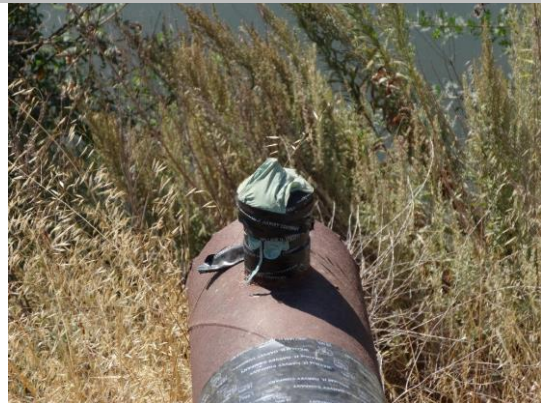
Photo 2 of 3 : UCIP\_FA\_2015\_2347.jpg

WS view: exposed steel pipe with siphon breaker. Looks siphon breaker needs repair.

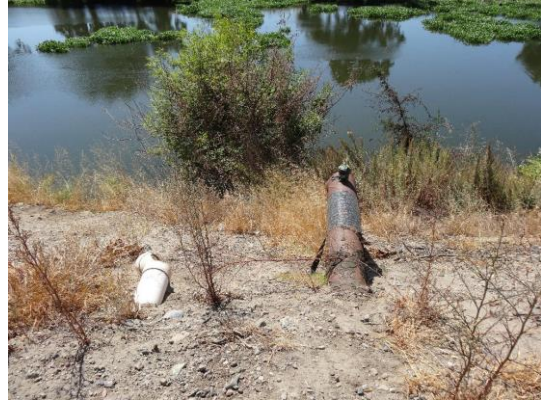
Photo 3 of 3 : UCIP\_FA\_2015\_2348.jpg

WS view: exposed steel pipe on levee slope. A pvc pipe on left.

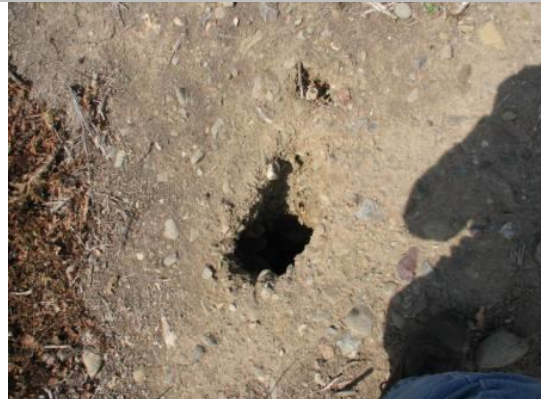
Photo 1 of 1 : FA\_2015\_RD2089\_316\_49\_20150910\_00028.jpg

11/10/2011 Deep burrow on waterside.

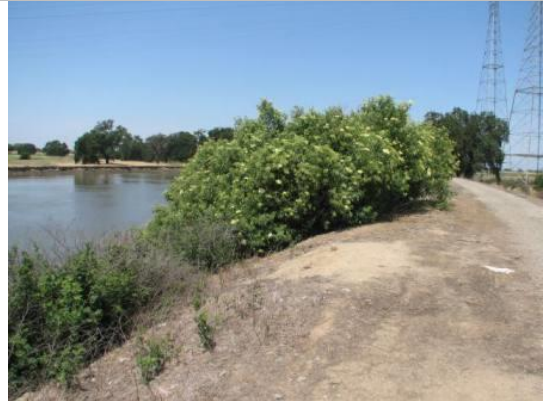
Photo 1 of 2 : FA\_2015\_RD2089\_317\_4\_20150910\_00003.jpg

05/24/2011 Updated photo of issue noted in Fall 2010 inspection.

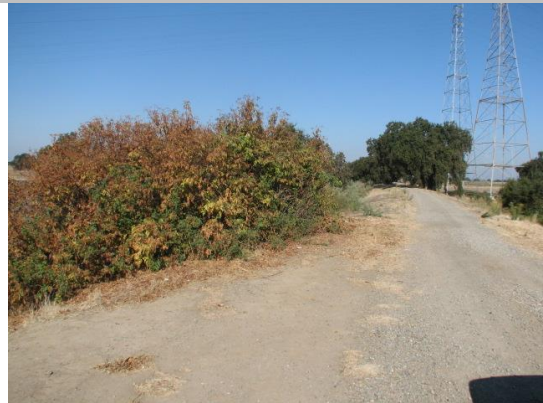
Photo 2 of 2 : FA\_2015\_RD2089\_317\_4\_20150910\_00004.jpg

Fall 2009 photo of unacceptable vegetation on levee slope.

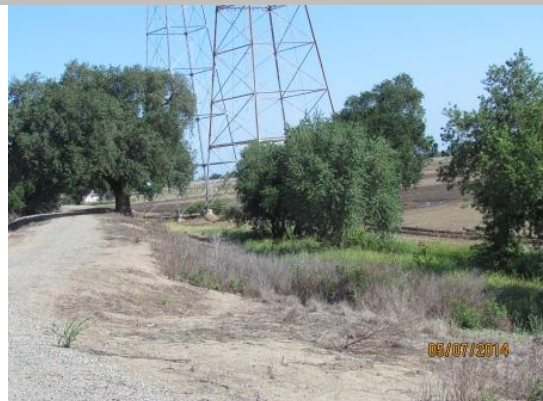
Photo 1 of 1 : FA\_2015\_RD2089\_317\_19\_20150910\_00020.jpg

View of the vegetation on the landside levee slope.

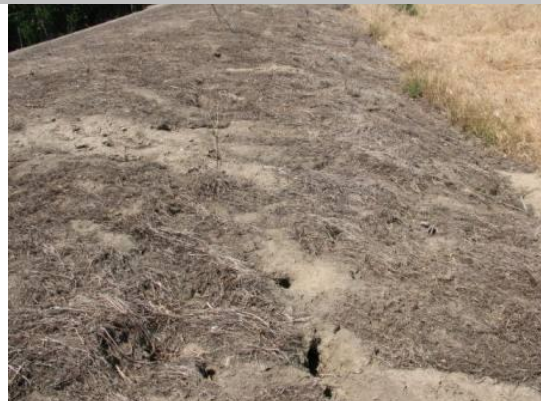
Photo 1 of 1 : FA\_2015\_RD2089\_317\_24\_20150910\_00023.jpg

05/24/2011 Active burrows, ground squirrel sighted in area.

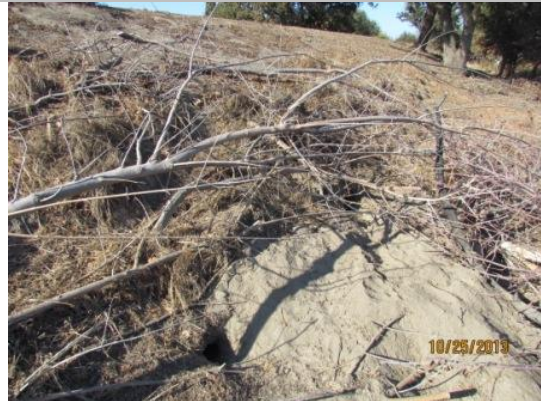
Photo 1 of 1 : FA\_2015\_RD2089\_317\_51\_20150910\_00033.jpg

View of the rodent burrow on the landside levee toe.

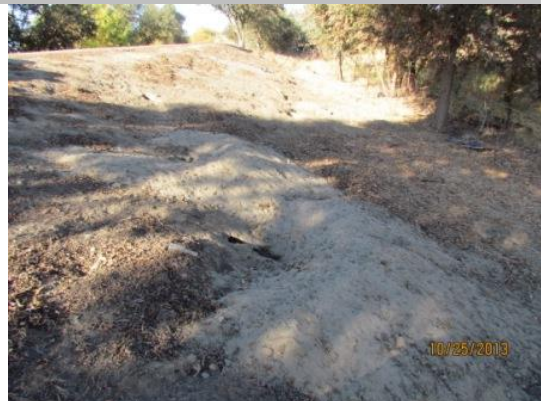
Photo 1 of 3 : FA\_2015\_RD2089\_317\_53\_20150910\_00035.jpg

View of the multiple rodent burrows on the landside levee slope.

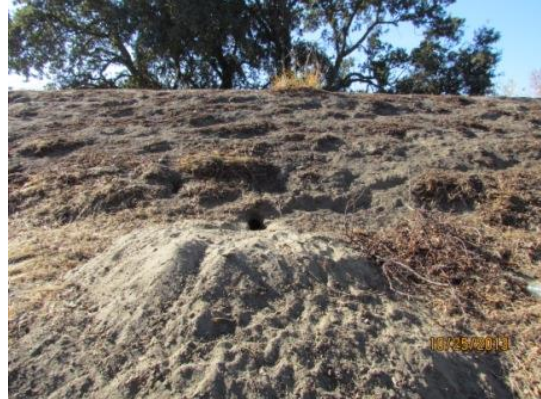
Photo 2 of 3 : FA\_2015\_RD2089\_317\_53\_20150910\_00036.jpg

View of the rodent burrow on the landside levee slope.

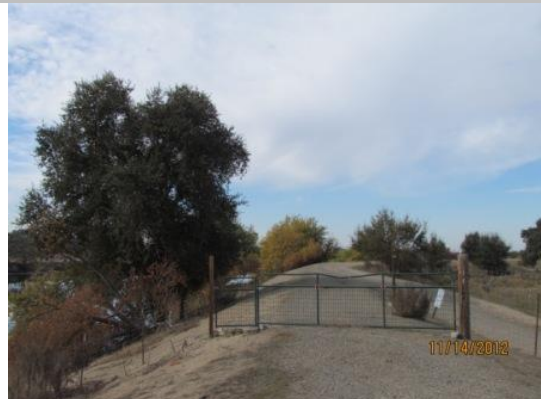
Photo 1 of 1 : FA\_2015\_RD2089\_317\_2\_20150910\_00002.jpg

View of gate across levee crown.

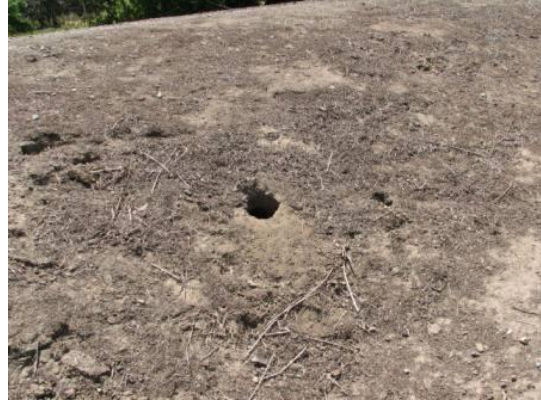
Photo 1 of 1 : FA\_2015\_RD2089\_317\_26\_20150910\_00024.jpg

05/24/2011 Active rodent burrow.

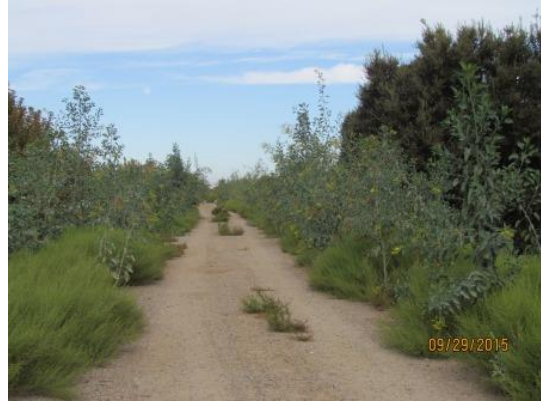
Photo 1 of 1 : FA\_2015\_RD2089\_317\_8\_20151005\_00041.jpg

View of tall vegetation limiting visibility and access on the levee.

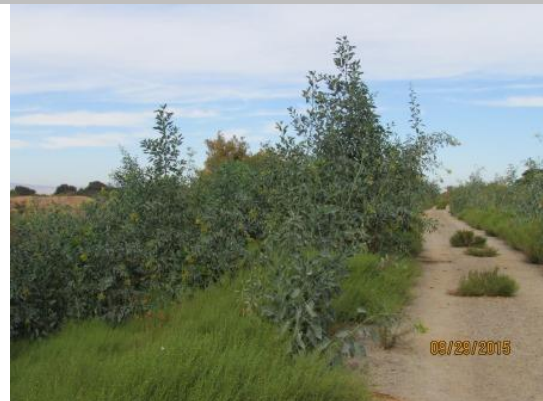
Photo 1 of 1 : FA\_2015\_RD2089\_317\_28\_20151005\_00042.jpg

View of the tall vegetation obstructing visibility and access.

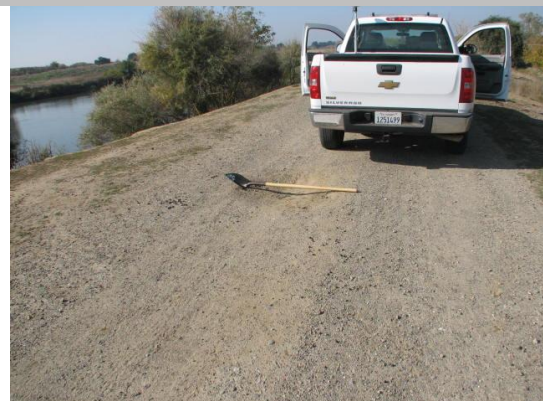
Photo 1 of 1 : FA\_2015\_RD2089\_317\_10\_20150910\_00011.jpg

11/10/2011 Depression in crown needs to be filled.

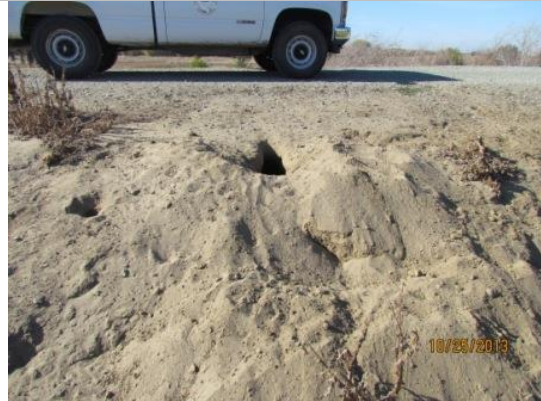
Photo 1 of 1 : FA\_2015\_RD2089\_317\_54\_20150910\_00038.jpg

View of the rodent burrow on the landside levee slope.

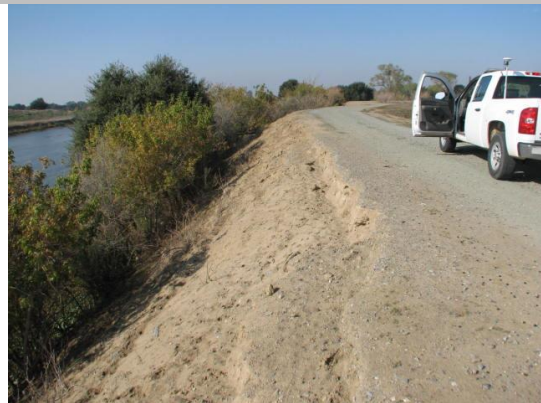
Photo 1 of 1 : FA\_2015\_RD2089\_317\_14\_20150910\_00016.jpg

11/10/2011 Approximately 1' scarp has been created by livestock travel.

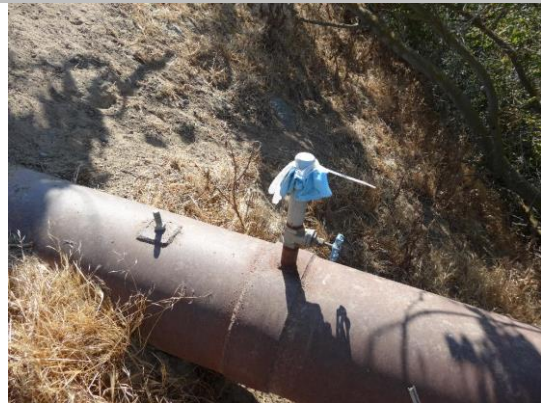
Photo 2 of 3 : UCIP\_FA\_2015\_0722.jpg

WS view: air relief valve on pipe. Pipe exposed in levee slope.

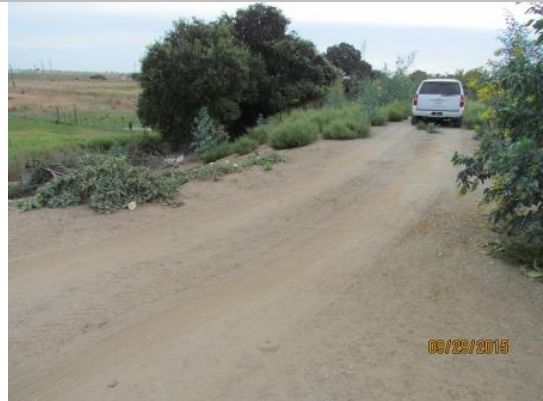
Photo 1 of 4 : FA\_2015\_RD2089\_317\_35\_20151005\_00044.jpg

View of the levee crown depression looking upstream.

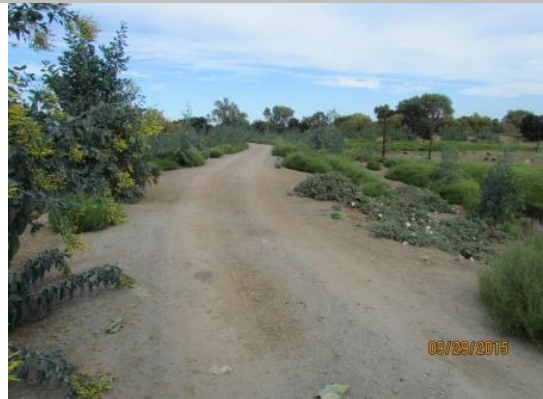
Photo 2 of 4 : FA\_2015\_RD2089\_317\_35\_20151005\_00045.jpg

View of the levee crown depression looking downstream.

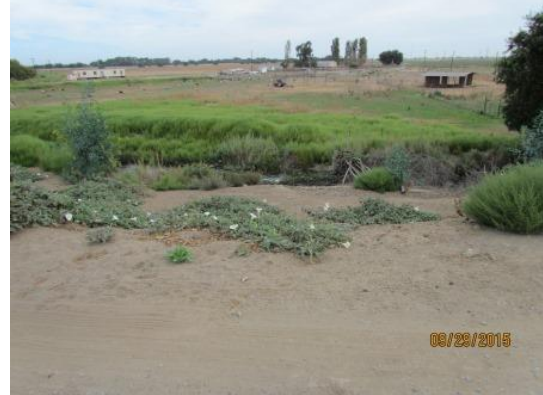
Photo 3 of 4 : FA\_2015\_RD2089\_317\_35\_20151005\_00046.jpg

View of the levee crown depression looking to the landside.

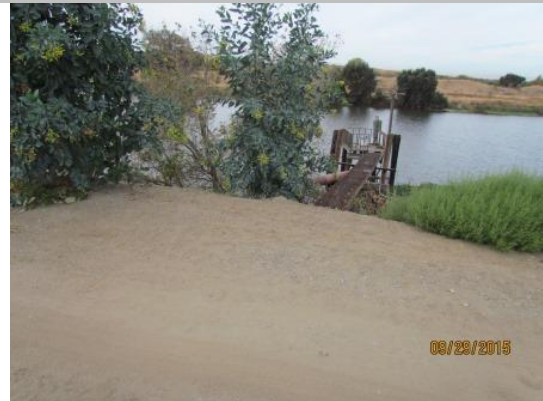
Photo 4 of 4 : FA\_2015\_RD2089\_317\_35\_20151005\_00047.jpg

View of the levee crown depression looking to the waterside.

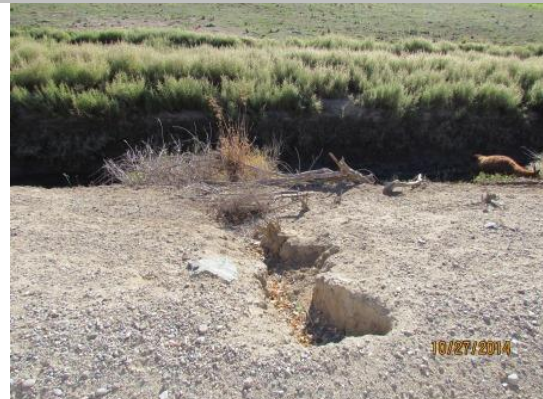
Photo 1 of 1 : FA\_2015\_RD2089\_317\_15\_20150910\_00017.jpg

View of the scour from surface runoff on the landside levee slope.

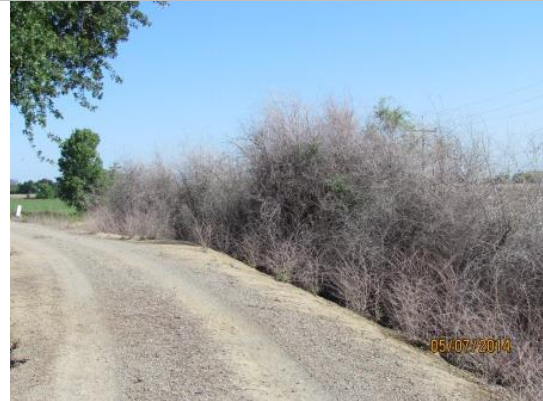
Photo 1 of 1 : FA\_2015\_RD2089\_317\_36\_20150910\_00027.jpg

Extremely thick dead brush prevents access and visibility.

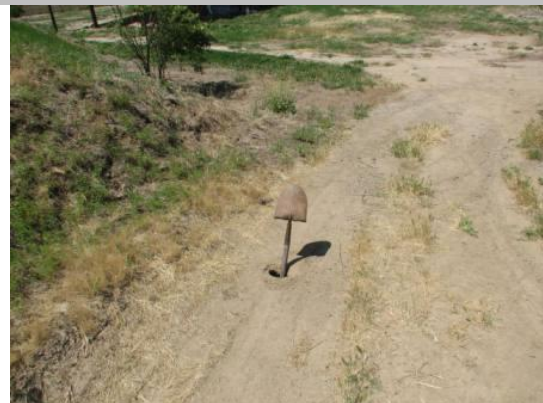
Photo 1 of 3 : FA\_2015\_RD2089\_317\_40\_20150910\_00028.jpg

05/24/2011 Deep vertical burrow in ramp on land side of levee.

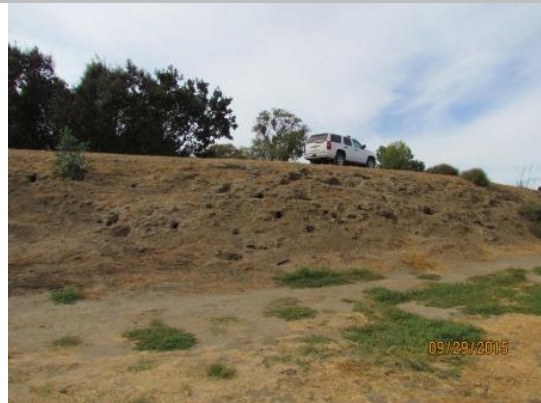
Photo 3 of 3 : FA\_2015\_RD2089\_317\_40\_20151005\_00043.jpg

View of the multiple rodent holes on the landside levee slope.

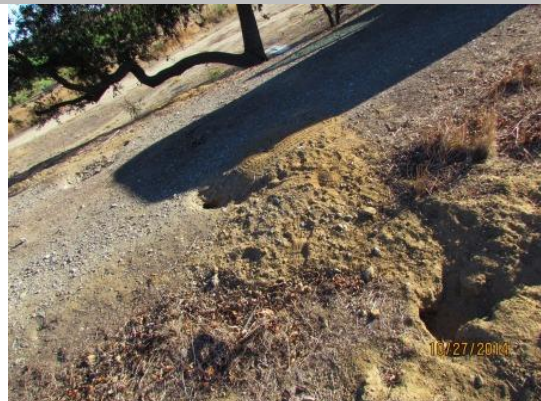
Photo 1 of 2 : FA\_2015\_RD2089\_317\_12\_20150910\_00013.jpg

View of several large rodent holes on the levee crown.

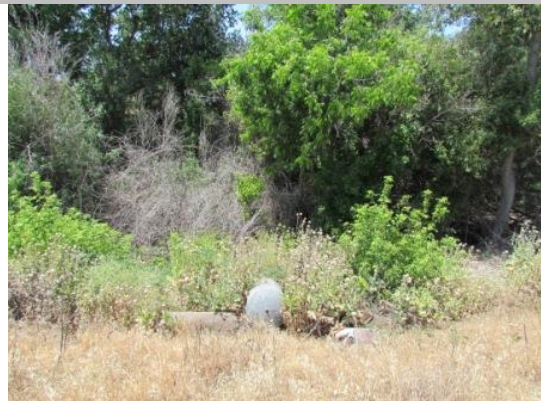
Photo 1 of 1 : FA\_2015\_RD2089\_317\_17\_20150910\_00018.jpg

View of water tanks disposed on waterside slope.

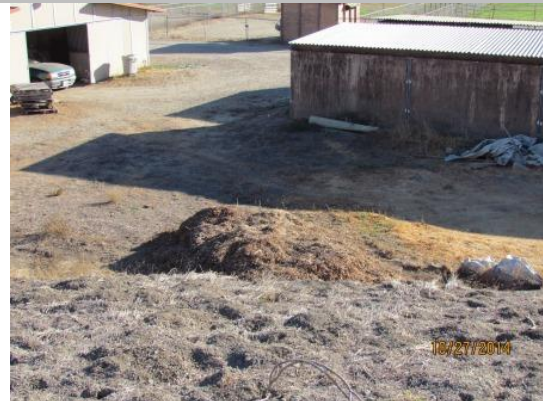
Photo 1 of 1 : FA\_2015\_RD2089\_317\_7\_20150910\_00007.jpg

View of the animal feed stockpiled at the landside levee toe.

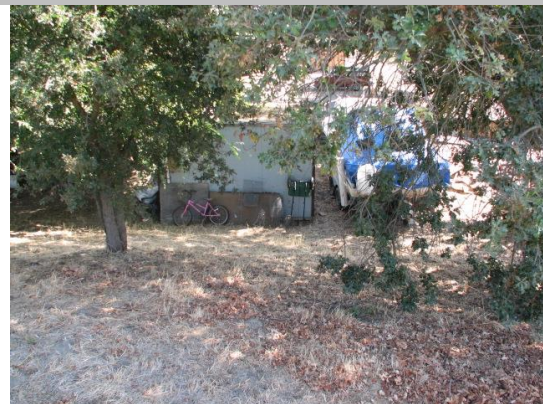
Photo 1 of 1 : FA\_2015\_RD2089\_317\_23\_20150910\_00022.jpg

Fall 2009 photo: Buildings and patio decks are built within 10-ft of the levee slope.

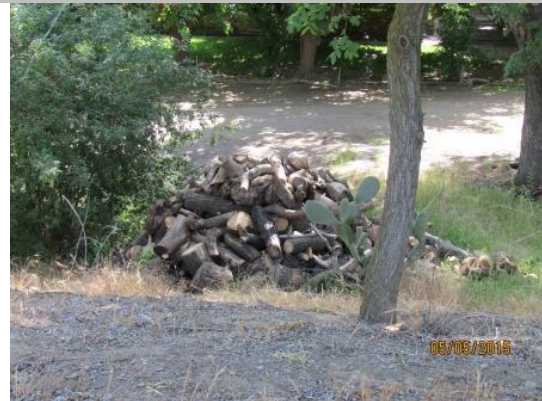
Photo 1 of 1 : FA\_2015\_RD2089\_317\_18\_20150910\_00019.jpg

View of the firewood piled at the landside levee toe.

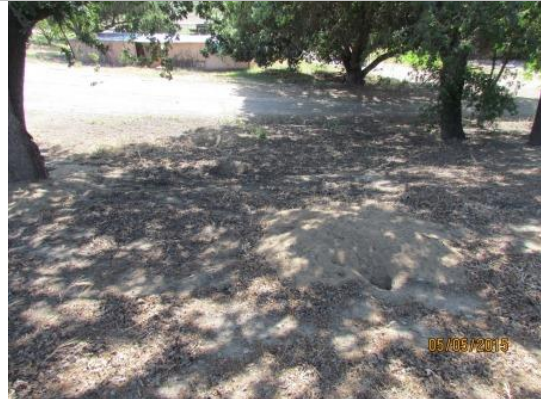
Photo 1 of 1 : FA\_2015\_RD2089\_317\_11\_20150910\_00012.jpg

View of the multiple rodent burrows on the landside levee slope.
